LOCOMOTION No.1

An Assessment of its History and Modifications
Through Archaeological and Archival Study

Michael R. Bailey MBE, DPhil, MA and
Peter H. Davidson MA (Cantab.)

June 2023

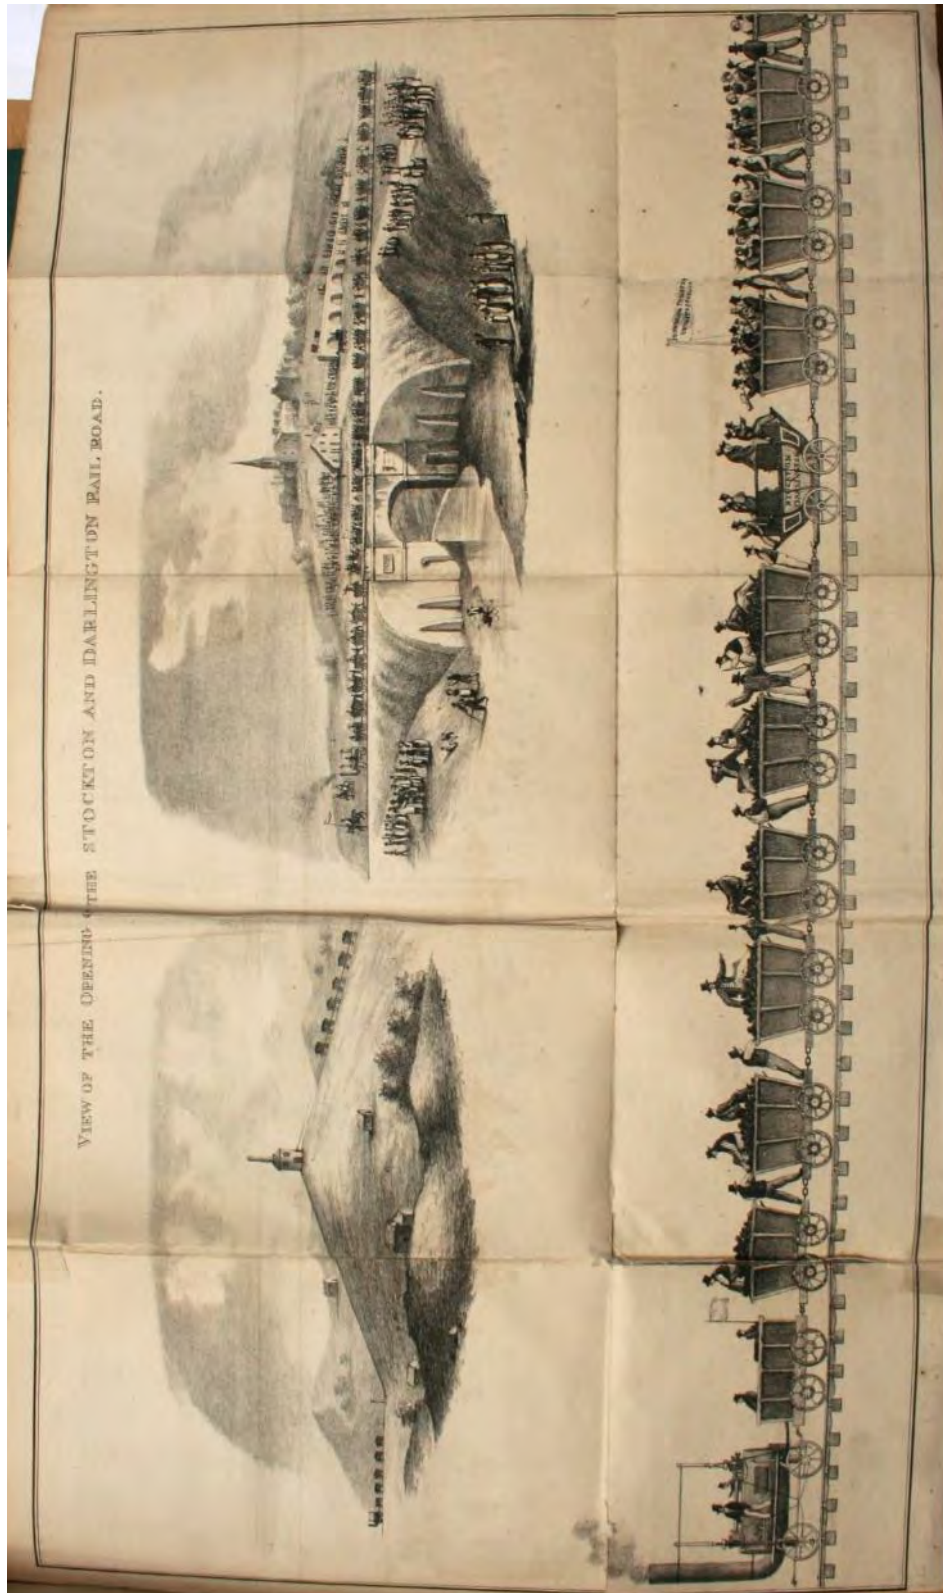
Fig. 1.4
Contemporary
illustrations of the
opening of the
Stockton &
Darlington Railway
on September 27th
1825 (1)

Although there is no specific contemporary evidence to support the temporary postponement of the parallel motion, there are three contemporary sketches of the opening day, which appear to show the locomotive with a slide-bar arrangement.

The close-up drawing of the train reproduced in Fig. 1.4 has clearly been copied from the drawing of Stephenson's patent locomotive with steam springs used on the Killingworth Railway, but with the specific omission of its surging chain. It is therefore possible that this sketch had been made copying the form of locomotive then being used on the Killingworth and Hetton colliery lines, and is not necessarily representative of *Active*'s appearance at the opening ceremony.

Fig. 1.8 (Left) Detail of Fig. 1.4 showing the *Active* and tender. The sketch has apparently been modified from an earlier sketch published in Newcastle (Right) of Stephenson's patent locomotive.

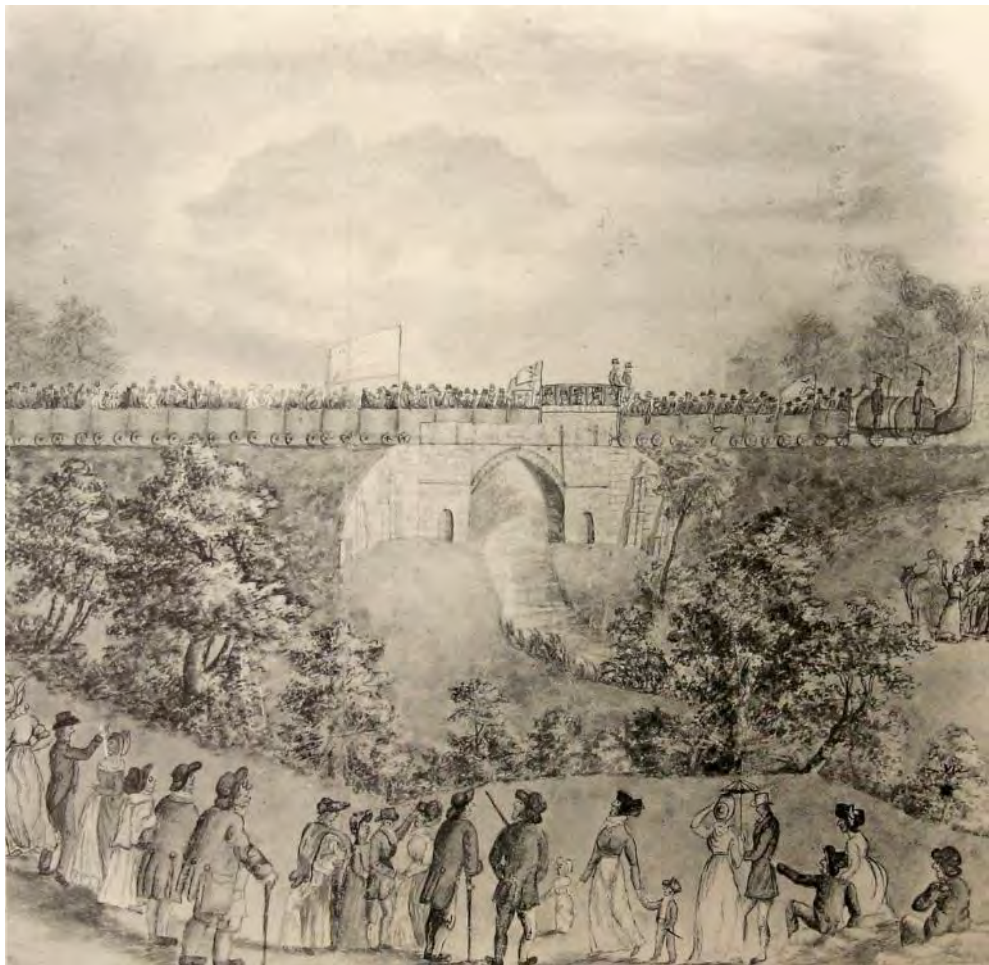
Fig. 1.5
Contemporary illustrations of the opening of the Stockton & Darlington Railway on September 27th 1825 (2).
[Science & Society Picture Library – 10199026 – artist unknown]

Fig. 1.7 Three contemporary images of the special opening day train hauled by *Active*. In each case the motion apparently shows slide bars for each cylinder above the boiler. [Images from Figs. 1.4 to 1.6 – details]

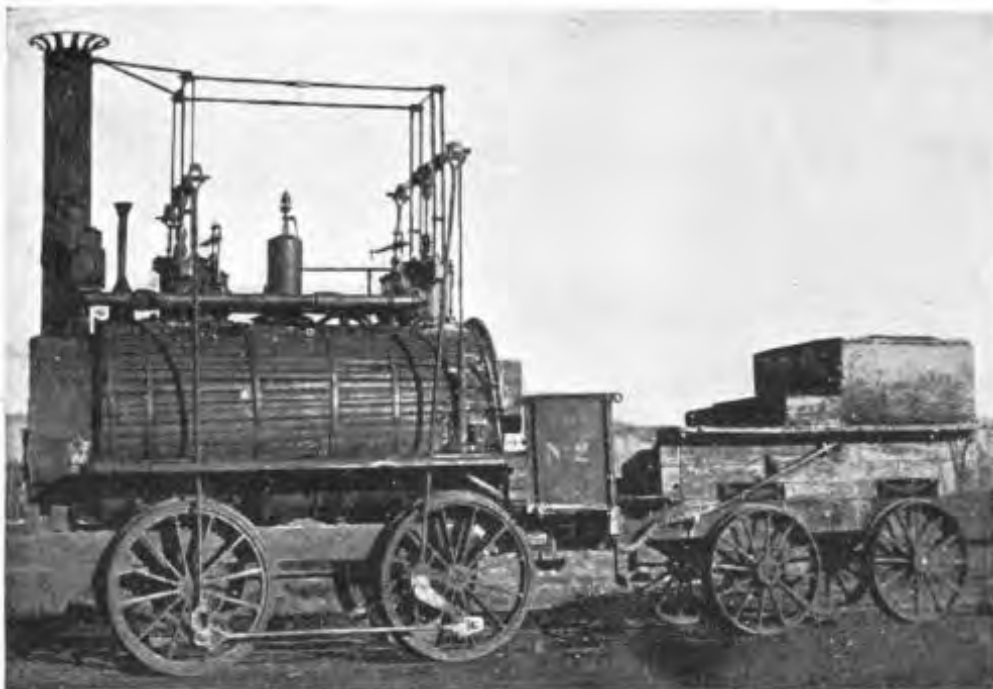
Fig. 1.9 Mount Moor Colliery locomotive No. 2, believed to be T/E No. 2 completed by Robert Stephenson & Co. in April 1826, with slide-bar motion.

Further evidence suggesting that *Active* had been built incorporating slide bars and crossheads may be seen regarding the first two locomotives that had been ordered from the Stephenson company in approximately July of 1824. Both had been ordered by Lord Ravensworth & Partners for use at their Mount Moor colliery railway at Springwell in County Durham. With the subsequent order of the two locomotives by the S & D R, priority was given to these latter, and manufacture of the Mount Moor locomotives (T/E Nos. 1 and 2) was postponed. They were eventually delivered in April 1826. It is noteworthy that they were fitted with slide-bars and crossheads rather than parallel motion, confirming that this earlier Killingworth type practice had been perpetuated into the first products of Robert Stephenson & Co.

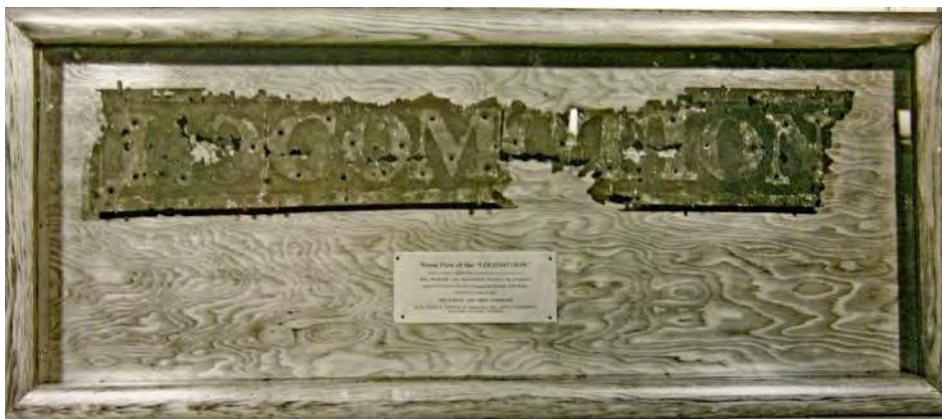
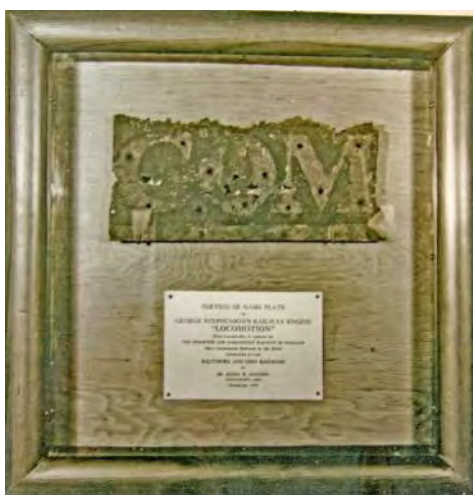
Fig. 8.2 Photographs of the *LOCOMOTION* nameplates included in the B & O R/R Museum's collection.

It is not known when the original nameplates had been removed from the locomotive, but in 1940 a Dr. Jessie B. Johnson (1880-1944) of Youngstown, Ohio, representing herself and her brother, V.C.S. Johnson, of Hemet, California, donated to the Baltimore & Ohio Railroad the corroded remains of two iron *LOCOMOTION* nameplates. They remain in the collection of the Baltimore & Ohio Railroad Museum in Baltimore.²⁴³ As part of this study, enquiries were made of the museum to ascertain if any paperwork survives that would determine the origin and provenance of these nameplates. However, no paperwork survives to provide this information. It would seem that Dr. Johnson's grandfather, William Johnson (born in Darlington in 1804), may have been the person who obtained, under unknown circumstances, the nameplates after *LOCOMOTION* was taken out of service in 1840/41. He emigrated to the United States in 1848 with his wife, Jane, and their children, including their fourth child, Catherine Hannah (1836-1907) and settled in Illinois. Catherine Hannah Johnson was Jessie Johnson's mother, so an apparent link has been established, although specific evidence that both the weighty nameplates went with the emigrant family has not been confirmed. That Dr. Johnson apparently knew of the origin of the plates is indicative that their origin had been relayed to her by her grandfather and mother.

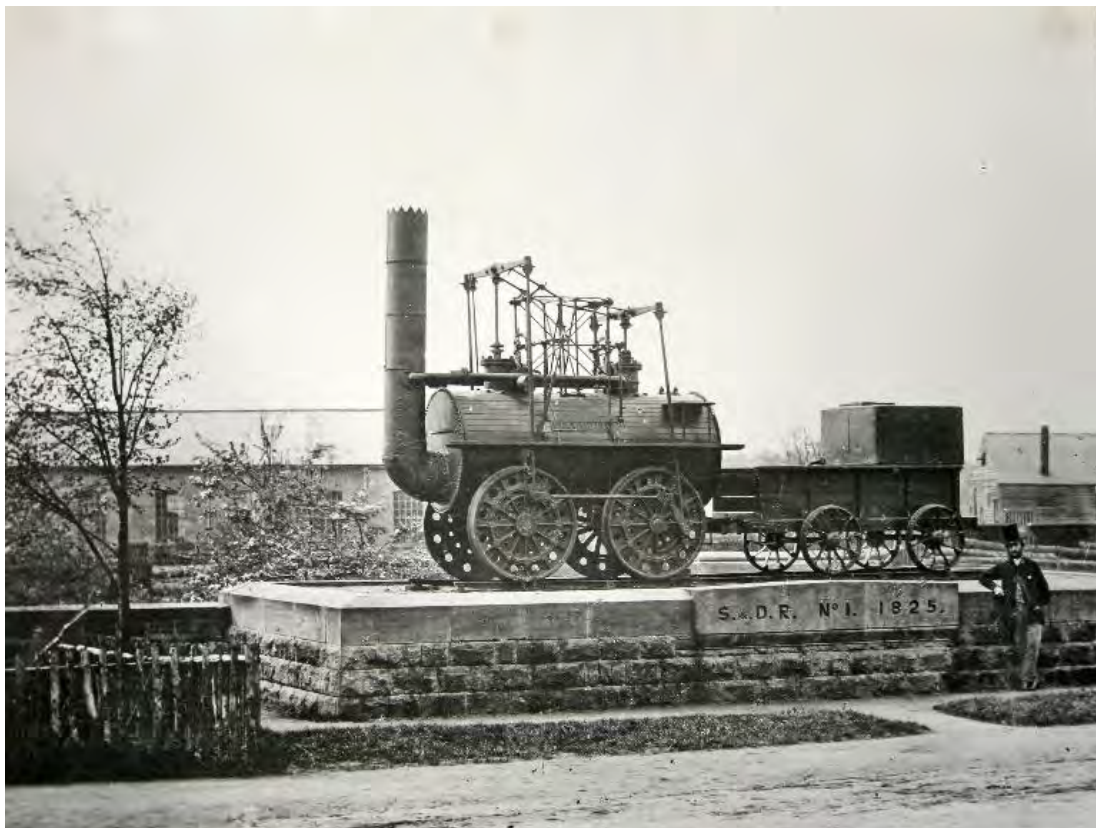
Fig. 8.3 Photograph taken in the late 1850s or early 1860s showing the replica nameplate fitted to the boiler. (The newly planted tree ahead of the pedestal is helpful in dating the picture)

On an unknown occasion, apparently within just a few years of the vehicle being placed on the pedestal, the omission of a *LOCOMOTION* nameplate was apparently pointed out, and moves were taken to fit a replica nameplate in the centre of the boiler's left-side, but possibly not on the right-side, that space being occupied by the boiler feed-pump. A further photograph, apparently taken in the late 1850s or early 1860s shows the new nameplate in place, but with the omission of the '1'. It is possible however that '1' was painted on the leading end of the boiler cladding on the right-side.

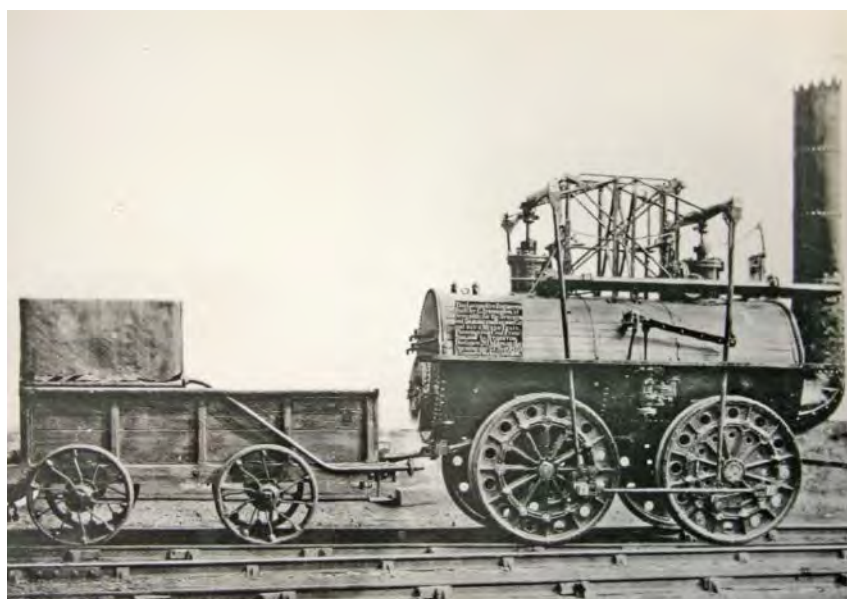
Fig. 8.8 Right-side view of *LOCOMOTION* taken for the 1875 Jubilee in Darlington. No name is carried on this side, but the number '1' is painted on the top right of the boiler cladding.

It has been written that the locomotive's nameplate on its left side was replaced by a later version, incorporating 'No.1' and '1925'.²⁵⁰ However, all the contemporary photographs and drawings show that it retained its replica 1850s/1860s *LOCOMOTION* nameplate, with number '1' painted on the boiler lagging just above it. On the right side of the boiler no nameplate was placed, whilst the number '1' was painted on the lagging towards the upper leading end. The locomotive, together with its tender and chaldron wagon, was returned after the event to its place on the North Road pedestal.

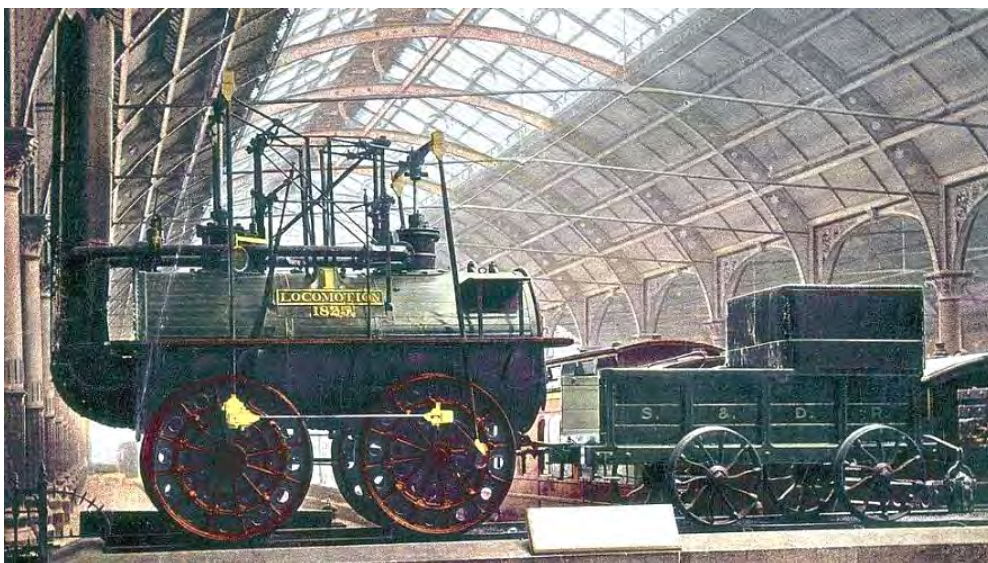
Fig. 8.14 *LOCOMOTION*, newly restored and repainted, and displaying its 'Paris' nameplates on its left side, together with a similar set on the right side, on the plinth at Bank Top station, Darlington. [SSPL Collection]

On its return from Edinburgh, the North Eastern Railway accepted that *LOCOMOTION*'s condition had deteriorated unacceptably.²⁶⁷ The locomotive and its tender were restored and re-painted in the North Road Locomotive Workshops in Darlington during 1891/2. The colour scheme was altered from olive green and black, to blue, red, yellow, white and black, with the brass bell and nameplate remaining unpainted.²⁶⁸ The artefact was no longer made available for exhibition elsewhere, and in April 1892 was placed on permanent and prominent display on a new plinth under the platform roof at the southern end of Darlington's Bank Top station.²⁶⁹ For this purpose an additional name/number/date plate, similar to that carried on its left side, was added to the locomotive's right side. The chaldron wagon that had formerly been displayed with it on the pedestal at North Road no longer accompanied it.

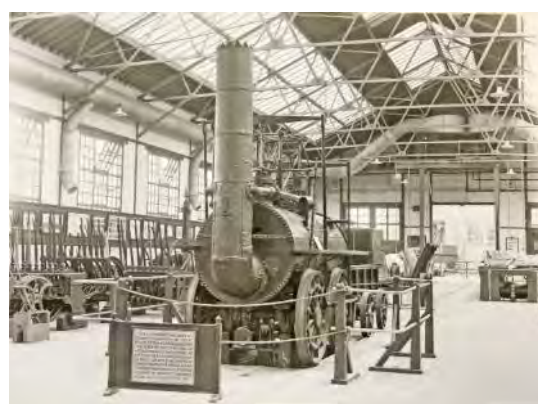
Fig. 8.19 *LOCOMOTION* returned to Darlington (Faverdale Works) showing the Electric motor and gearing for operating the driving and valve motions.
[NRM, York HQ photo collection Box 1]

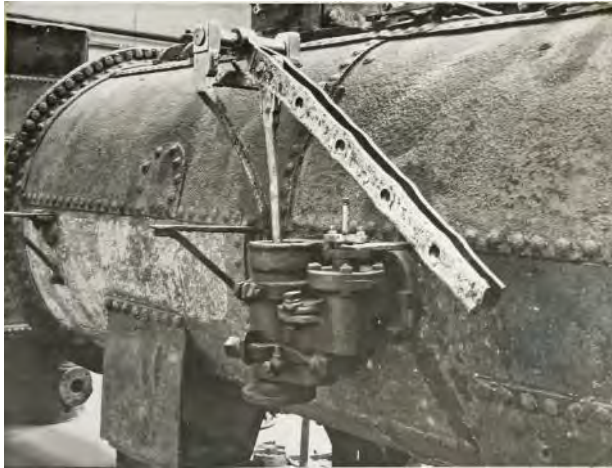
Figs. 8.28 & 8.29 Boiler and tender stripped down during the restoration programme in Darlington Locomotive Works, March to June 1961.

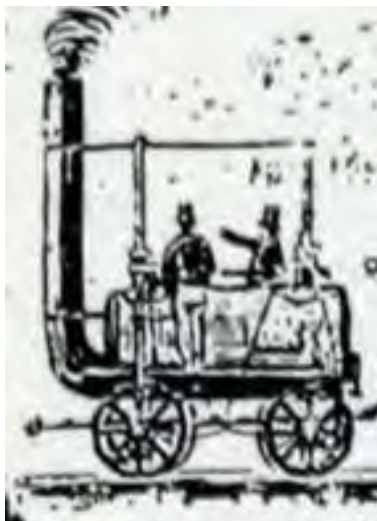
Fig. 10.2 Contemporary view of the opening day of the S & D R. showing spoked wheelsets adopted on *Active*.

That this form of wheel had been adopted also for the works' first locomotive is suggested in a contemporary engraving.

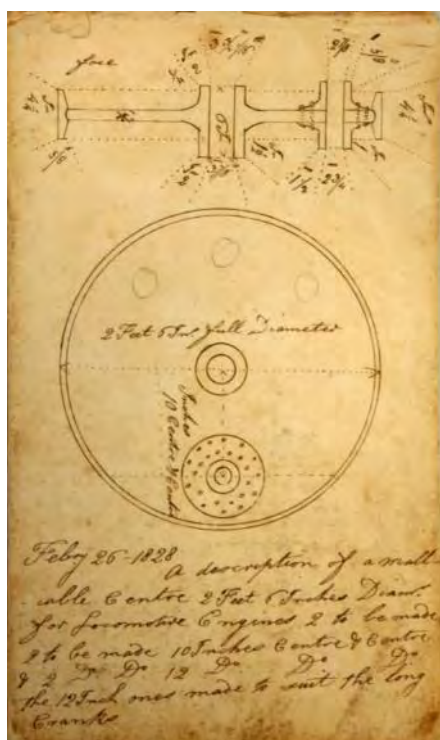
Fig. 10.6 Design of wrought iron inner locomotive wheel prepared by Timothy Hackworth, dated February 26th 1828.

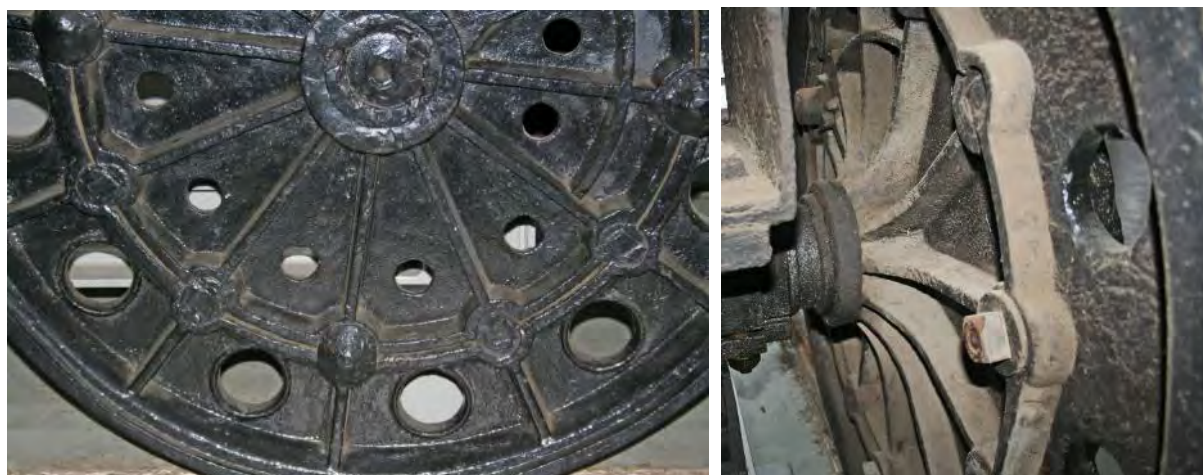
Fig. 10.10 Front right-side wheel, outer face and inner face.

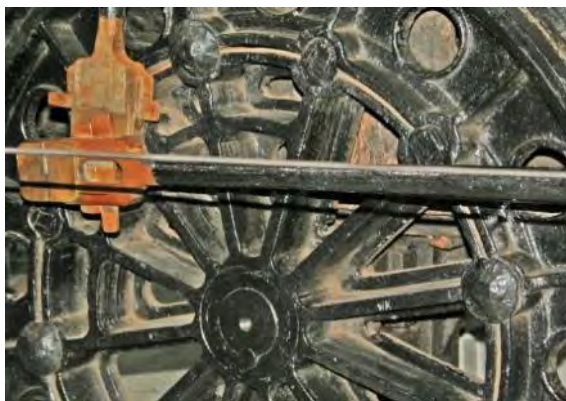
Fig. 10.11 Rear right-side wheel, outer and inner faces, showing the three forms of lightening holes.

The rear right side wheel has been formed differently from the other wheels and may be of an earlier form. The outer face of its hub has no strengthening ring, the end of the axle fitted up to it, whilst on the inner face the strengthening ring is $2\frac{3}{8}$ in wide. Its twelve spokes, $\frac{3}{4}$ inch wide, are $4\frac{1}{2}$ in deep and located on the outer face of the wheel only. The centre's inner face has a flat surface radiating from the hub.

It has segmental shaped lightening holes between the spokes, that are 4 in wide at their widest point and $8\frac{1}{4}$ in deep at their deepest point. It has smaller $4\frac{1}{4}$ in deep 'pear-drop' holes for the four smaller gaps between the strengthening arc and the hub, in addition to which there are circular ($1\frac{1}{2}$ in diameter) or elongated (1 in wide and 4 in long) holes between the strengthening arc and the facing ring.

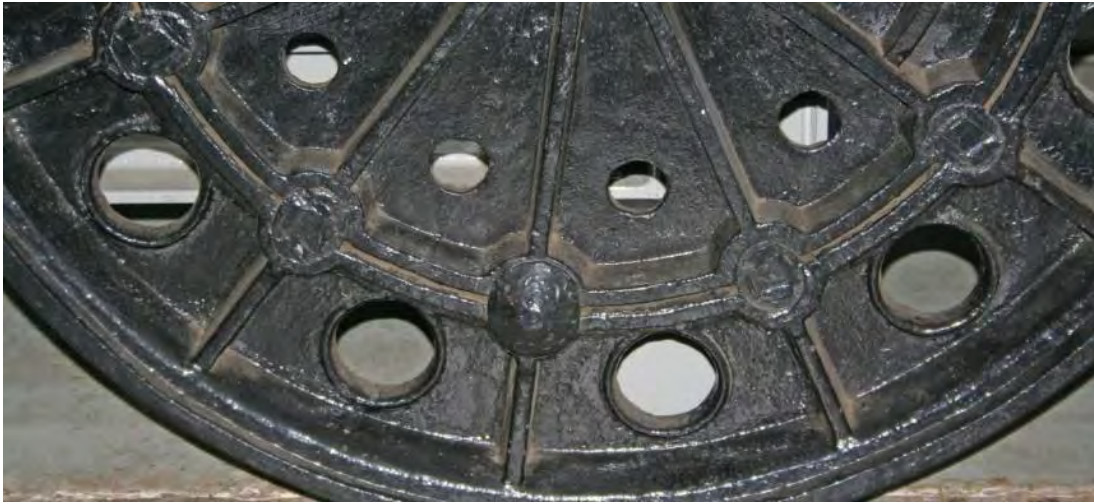
Fig. 10.12 Front-right wheel rim casting

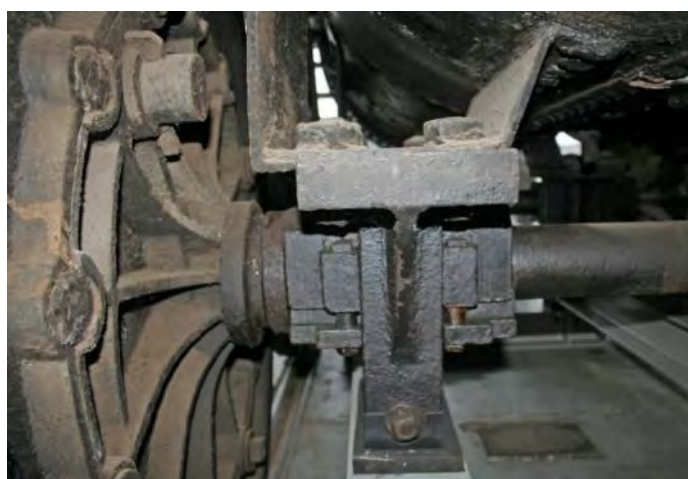
Fig. 11.4 Forward-facing end view of the left rear horn and axle box assembly.

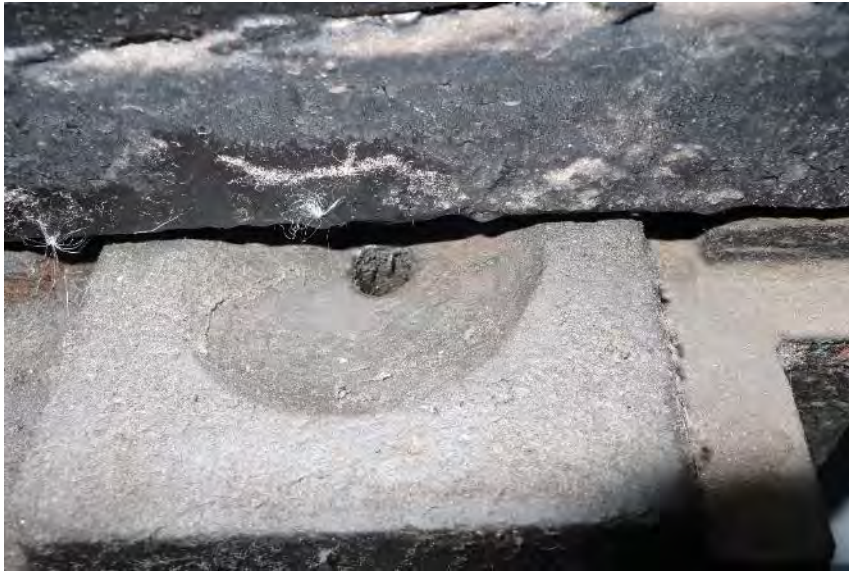
Fig. 11.5 Upper surface of the front left axle-box showing the 'birdbath' lubricant reservoir and hole down to the bearing.

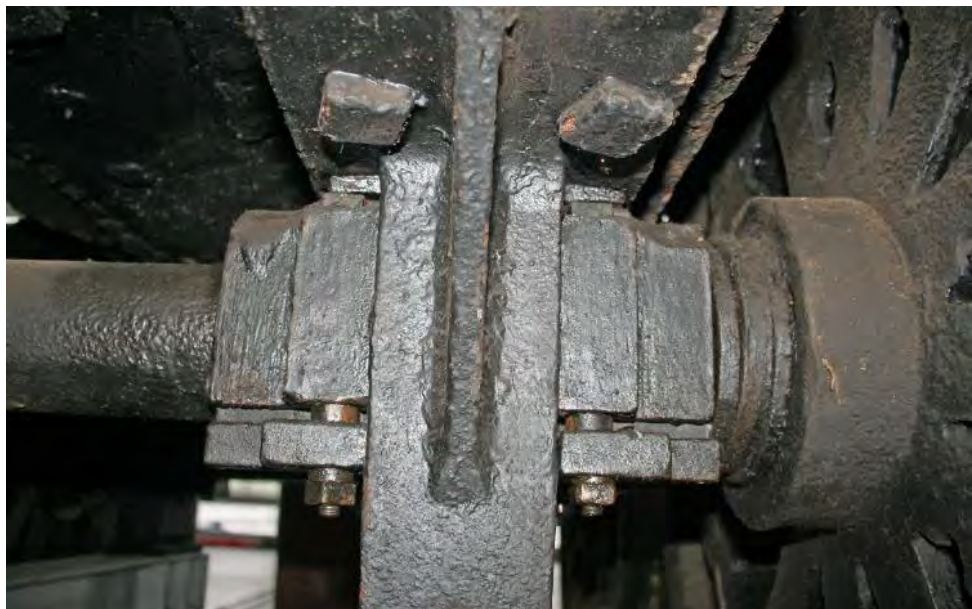
The axle-boxes are separated from the wheels by wrought iron spacers between $1\frac{1}{4}$ in and $2\frac{1}{4}$ in wide and $5\frac{3}{4}$ in diameter. The front left side spacer is however replaced by the $3\frac{1}{2}$ in wide valve drive eccentric and a spacer (Section 20).

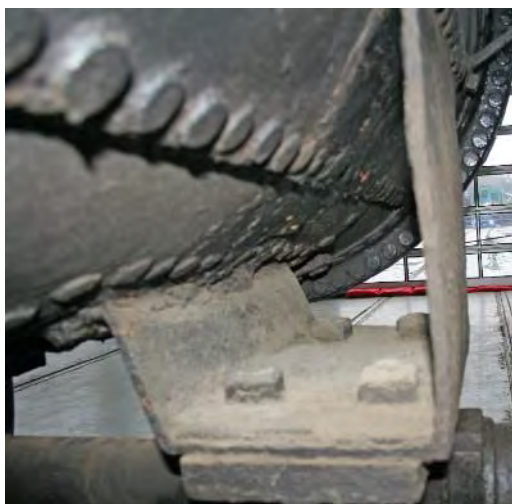
Fig. 12.3. Front right boiler support bracket and bottom reinforcing plate.

The four boiler support brackets, one above each end of each axle, all differ slightly. They are formed from $\frac{1}{2}$ in thick wrought iron plate and consist of flat-bottomed U shapes, with the tops bent outwards to match the slopes of the boiler. The higher, outer, arms are nominally vertical and are 19 in long, of which 3 in are bent over to provide flanges for riveting to the boiler. The shorter, inner, arms are sloping and are 12 in long, of which the top 3 in are bent over, as above. The flat bottoms of the brackets are $9\frac{3}{4}$ in wide internally and have holes for four $1\frac{1}{4}$ in bolts.

A $\frac{1}{2}$ in thick plate has been inserted in the bottom of each bracket (Figs. 12.3 and 12.4). The plate in the front right bracket is too wide and tightening the four bolts has caused the plate to curl upwards slightly.

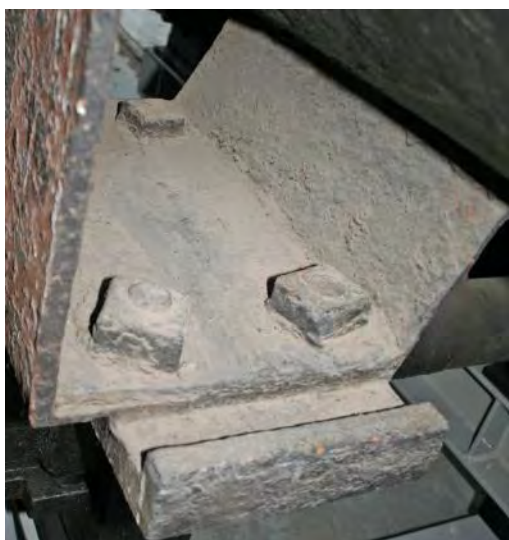
Fig. 12.4. $1\frac{1}{2}$ in gap between horn-plate shoulder and rear left boiler support bracket.

The design of the plates at the tops of the horns provides shoulders at each end, separated by 1 ft 9 in into which the bracket was supposed to fit (Section 11) with no allowance for inevitable errors in the positioning of the brackets. Presumably the intention was that the locomotive tractive effort would have been carried from the horns via these shoulders to the boiler (and thence the drawbars) rather than by the above $1\frac{1}{4}$ in bolts. The brackets themselves are of varying lengths and are incorrectly located longitudinally, relative to the horn top plates. Part of the problem here is that distortion of the boiler and the shapes of the plates have resulted in the bottoms of the brackets being out of alignment with the flanges at their tops. The positions of the latter, and locational errors there, are shown in Fig. 13.6.

The bottom of the front left bracket is the correct 1 ft 9 in long but set $\frac{5}{8}$ in too far towards the rear of the boiler. This has required the rear horn-plate shoulder to be cut away by $\frac{5}{8}$ in. The bottom of the front right bracket is the same except the rearward error and shoulder cut-away is only $\frac{3}{8}$ in. The bottom of the rear left bracket is only 1 ft 6 in long and set $\frac{1}{2}$ in too far towards the front of the boiler, leaving gaps to the horn-plate shoulders at either end. The bottom of the rear right bracket is 1 ft $6\frac{3}{8}$ in long and is set 1 in too far to the rear of the boiler, which required the rear horn-plate shoulder to be slightly cut away and leaving a $1\frac{7}{8}$ in gap to the front shoulder.

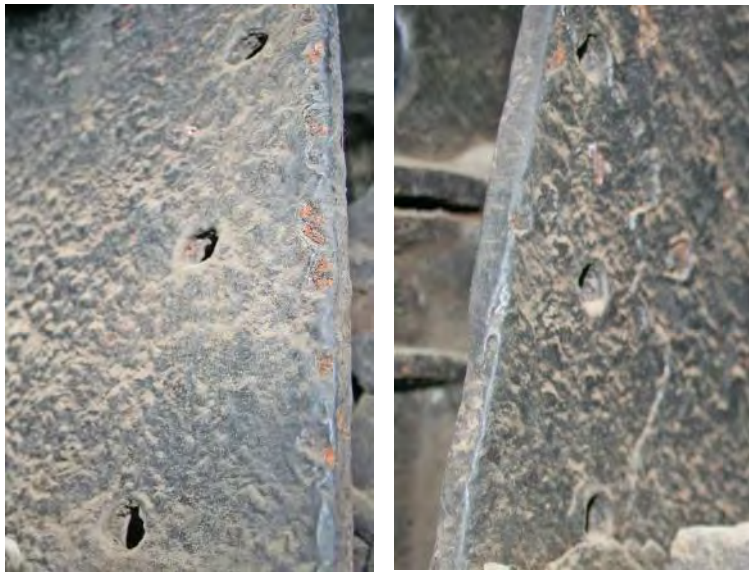
Fig. 12.5. Rows of three holes in vertical arms of front left and front right boiler support brackets.

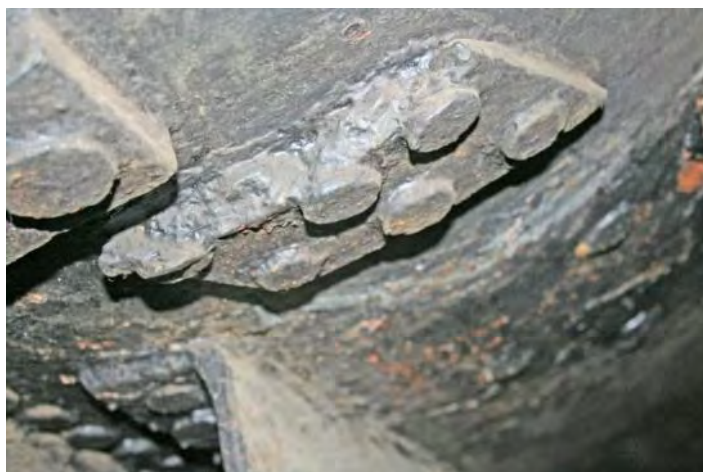
Fig. 13.4. Remains of bar riveted under the front left of boiler barrel.

A fragment of the end of a stout bar remains riveted to the front left of the boiler barrel adjacent to the bottom flange of the boiler support bracket. This clearly served no purpose in the normal operation of the locomotive. It is possible that a bar at this location was required to steady the locomotive when it operated at Roddymore Colliery (Section 7).
